**FINAL REPORT
APRIL 2003**

REPORT NO. 03-09

**GRATE PALLET 8232 (GP-8232) VEHICLE PALLET, EVALUATION TESTS
MIL-STD-1660, "DESIGN CRITERIA FOR AMMUNITION UNIT LOADS" &
TP-94-01 (REV 1), "TRANSPORTABILITY TESTING PROCEDURES"**

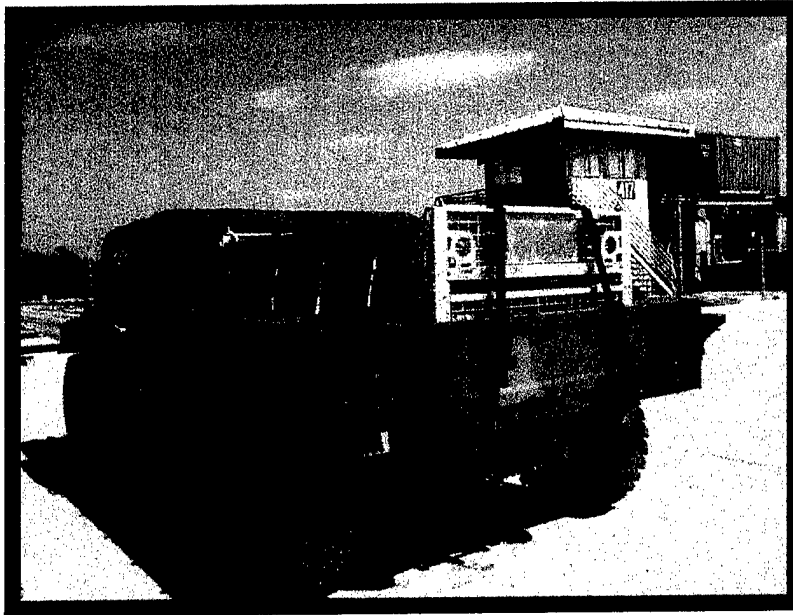
Photo 14. GP-8232 Secured in the HMMWV

C. TRANSPORTABILITY TESTING. Following completion of the MIL-STD-1660 testing a second GP-8232 Vehicle Pallet was loaded for the Transportability Testing and secured in the High Mobility Multipurpose Wheeled Vehicle (HMMWV). Photo 14 shows the GP-8232 Vehicle Pallet secured in the HMMWV. The shape of the tie-downs on the GP-8232 Vehicle Pallet would not allow the strap hooks or keepers to properly engage.

The shape of the tie-down rings on the GP-8232 Vehicle Pallet would not allow the strap hooks or keeper to properly engage.

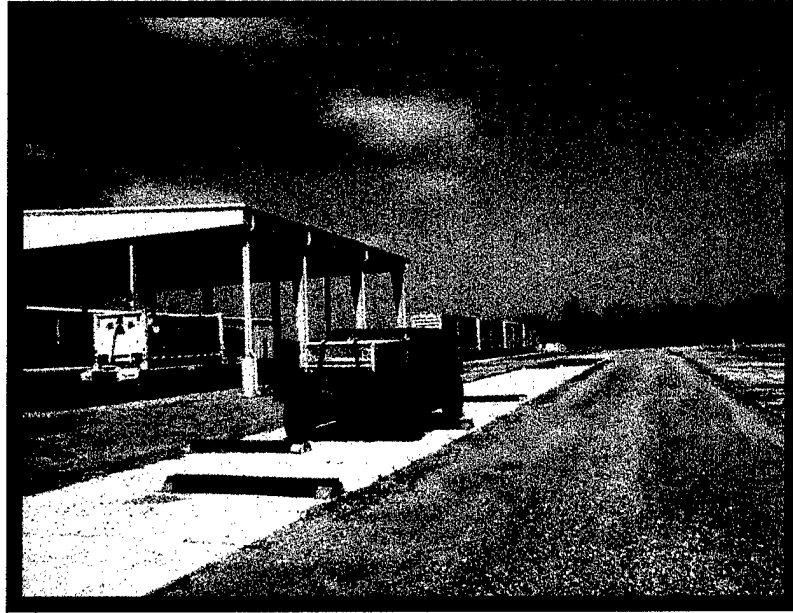
Photo 15. GP-8232 Vehicle Pallet During Hazard Course Transport

- a. Figure 4 lists the average speeds of the test load through the Hazard Course Passes 1 and 2.
- b. No damage occurred. The GP-8232 Vehicle Pallet maintained adequate integrity and safe handling capability and testing was continued. Photo 15 shows the GP-8232 Vehicle Pallet during transport over the Hazard Course.

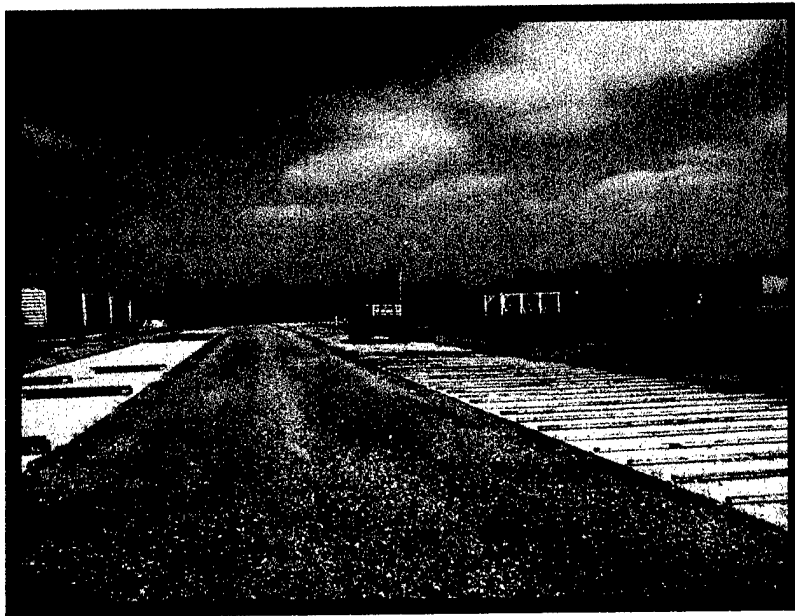
Photo 16. GP-8232 Vehicle Pallet During Washboard Testing

e. **WASHBOARD COURSE:** No additional damage occurred. The GP-8232 Vehicle Pallet maintained adequate integrity and safe handling capability and testing was continued. Photo 16 shows the GP-8232 Vehicle Pallet during transport over the Washboard Course.
